NATIONAL TRANSPORTATION SAFETY BOARD

HAZARDOUS MATERIALS ACCIDENT REPORT

DERAILMENT OF
A CSX TRANSPORTATION FREIGHT TRAIN
AND FIRE INVOLVING BUTANE
AKRON, OHIO
FEBRUARY 26, 1989

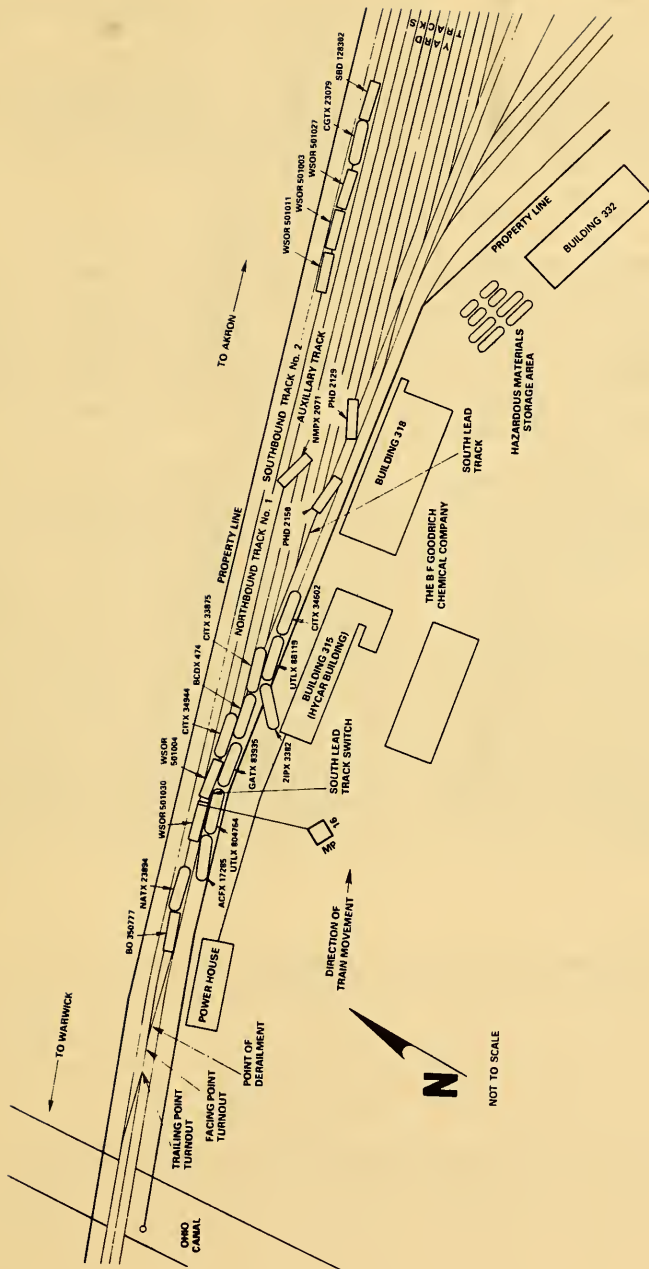
Figure 3.--The accident site.

The accident occurred near a B.F. Goodrich Chemical Company plant, and several tank cars of butane came to rest adjacent to B.F. Goodrich's building number 315 (figure 3). One of these tank cars (UTLX 88119) lost all of its butane (about 30,000 gallons) after sustaining a tear 15 feet 9 inches long in its sidewall. A second tank car (CITX 33875) lost butane through a 13-inch crack in its sidewall. A third tank car (ZIPX 3382) leaked butane through a valve in the dome. Tank car ZIPX 3382 was overturned and rested about 5 feet from the northwest corner of building 315; the tank car's pressure relief valve was obstructed by the ground and the car was involved in fire. Building 315 was 75 feet from the northbound track.

Building 315 housed a B.F. Goodrich latex manufacturing operation. That operation involved the use of acrylonitrile, butadiene, and styrene monomer, which were stored in tanks nearby (see figure 3). Additionally,

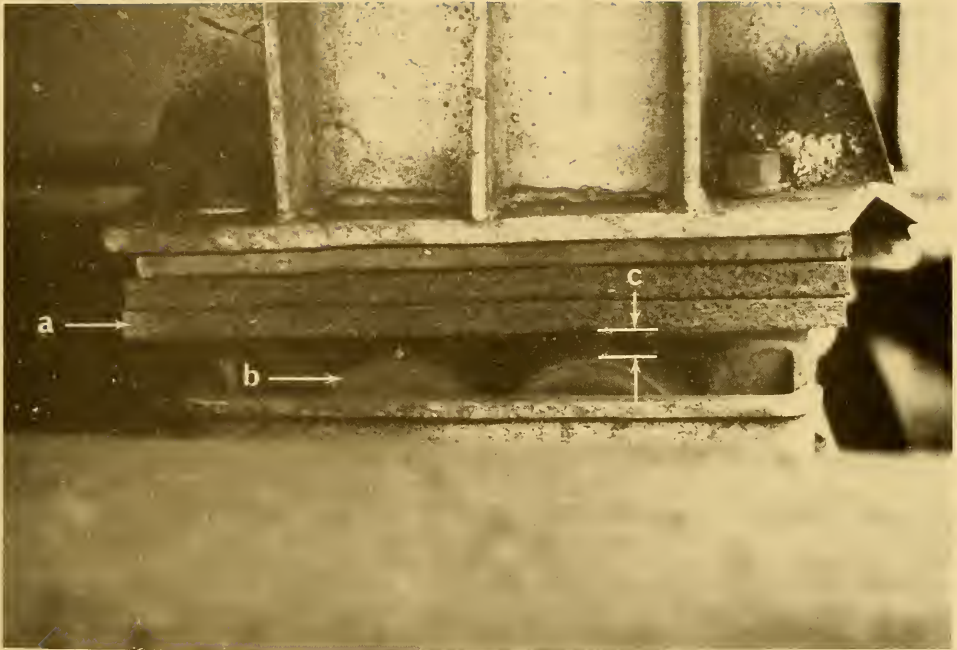
After car WSOR 501003 was rerailed and after its load of sand was leveled, the side bearing clearances were measured. (A side bearing clearance is the distance between a side bearing roller on a truck and a side bearing plate attached to the car body bolster above the roller; this clearance is illustrated in figure 16.) (One of the two truck side bearing rollers on the A-end right side was missing.) The measurements were as follows:

³⁵ Maximum clearance permitted by FRA regulations is 3/4 (12/16) inch. There is no minimum clearance; however, constant contact is not permitted for the type of bearing used on WSOR 501003.

Figure 16.--Components of a side bearing: (A) the side bearing plate attached to the car body bolster, (B) the roller attached to the truck, and (C) the side bearing clearance in-between.

The Field Manual of the Interchange Rules of the AAR, Rule 47(E)(2), however, states that side bearings must have 3/16-inch minimum to 5/16-inch maximum clearance. (This clearance does not apply to constant-contact type side bearings.) The AAR considers the FRA regulations to be safety standards, and it considers the AAR rules to be maintenance standards that are designed to identify and correct problems before the FRA regulations are violated. The AAR considers the FRA maximum side bearing clearance to be safe.
